Tree Survey & Arboricultural Impact Assessment of mature trees and hedgerows at a site in Waterrock, Co. Cork

Date : 17/10/22

Haven Falls Ltd,
C/o McCutheon Halley,
Joyce House,
6 Barrack Square,
Ballincollig,
Co.Cork

George Earle, *Dip Arb, TechArbA, Cert Hort*

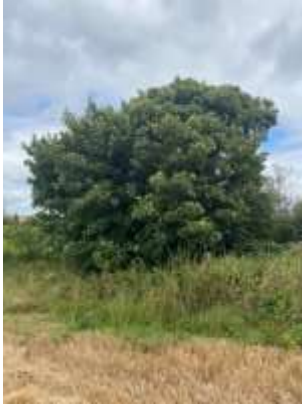
Fig 1 : T771

Tag No.	Species	Age	Height	Diameter	Condition	Crown Spread	RPA (M ²)	Comments	Recommendations	RC	ERC
771	Sycamore (<i>Acer pseudo Platanus</i>)	M	12m	40cm	Fair	N 3m S 4m E 2m W 5m	72	Dense ivy on main stem, ivy penetrating beneath the cambium, possible pathogen entry points, straight stem to 4m, three large limbs growing from the base West side make up ½ of lower crown, minor cavity @3m North side of main stem, limb broken East side of main stem @4m, minor decay observed at this point, a mallet test resulted in sound wood and no cavity present, branches cut on East side @3m by machinery, epicormic growth from the cuts	Decay on main stem prevents long term sustainability and it is recommended to fell and remove this tree	U	<10

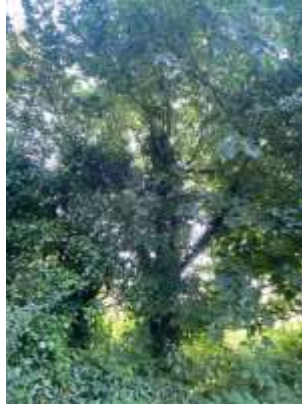
Fig 2 : T772

Tag No.	Species	Age	Height	Diameter	Condition	Crown Spread	RPA (M ²)	Comments	Recommendations	RC	ERC
772	Ash (<i>Fraxinus excelsior</i>)	Y	8m	30cm	Poor	N 3m S 2m E 2m W 3m	41	Coppiced previously aprox 15yrs ago @ 2m, & pollarded @ 5m aprox 5yrs ago, heavy ivy on main stem into upper crown, multiple branches@2m, one main leader, crown is restricted by T771, poor developed crown branches previously cut on East side @ 4m,	High likelihood of future contamination with ash dieback (<i>Hymenoscyphus fraxineus</i>), poorly formed tree. It is recommended to fell and remove this tree	U	<10

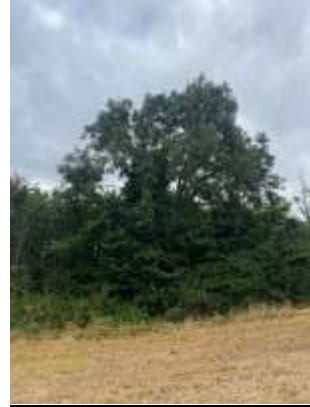
Fig 3 : T773

Tag No.	Species	Age	Height	Diameter	Condition	Crown Spread	RPA (M ²)	Comments	Recommendations	RC	ERC
773	Ash (<i>Fraxinus excelsior</i>)	M	12m	90cm	Fair	N 6m S 5m E 3m W 1m	366	Growing from a stone ditch, large bole to 1m, divides into two stems @1m & 3 @1.5m, minor cavity @ 1.2m East side, dense ivy on main leader into upper crown, branches have been cut on West side leading to an imbalance of the crown, heavier crown to the North and East,	Cavity poses a future hazard over the laneway, high possibility of future contamination with ash dieback (<i>Hymenoscyphus fraxineus</i>), it is recommended to fell and remove this tree	U	<10

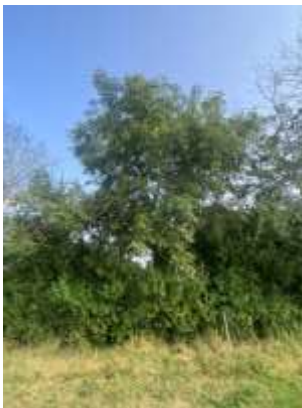
Fig 4 : T774

Tag No.	Species	Age	Height	Diameter	Condition	Crown Spread	RPA (M ²)	Comments	Recommendations	RC	ERC
774	Ash (<i>Fraxinus excelsior</i>)	Y	8m	25cm	Fair	N 4m S 4m E 4m W 4m	28	Straight stem to 1.5m splits in 2 at this point East and West, poor union and compressed wood between the co-dominant stems, heavy ivy on stems to 4m, broken branch @4m East side, tree has been pollarded (topped) approx 5 yrs previous and the epicormic growth is broken at this point,	Poorly formed tree with high possibility of contamination with ash dieback (<i>Hymenoscyphus fraxineus</i>), it is recommended to fell and remove this tree	U	<10

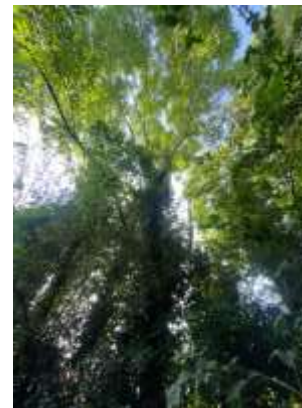
Fig 5 : T775

Tag No.	Species	Age	Height	Diameter	Condition	Crown Spread	RPA (M ²)	Comments	Recommendations	RC	ERC
775	Ash (<i>Fraxinus excelsior</i>)	Y	11m	25cm	Poor	N 5m S 4m E 4m W 5m	28	Straight stem to 2.5m, was cut to this height approx 20yrs previous, three main stems averaging 15cm diameter, sparse crown, minor deadwood in upper crown, heavy ivy on main stem,	Tree is showing poor vigour and has a high likelihood of future contamination with ash dieback (<i>Hymenoscyphus fraxineus</i>), it is recommended to fell and remove this tree	U	<10

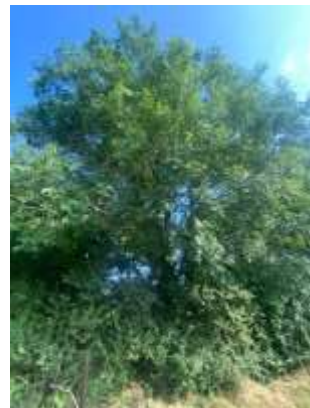
Fig 6 : T776

Tag No.	Species	Age	Height	Diameter	Condition	Crown Spread	RPA (M ²)	Comments	Recommendations	RC	ERC
776	Ash (<i>Fraxinus excelsior</i>)	M	14m	90cm (x 2)	Poor	N 4m S 6m E 5m W 6m	366	Large mature tree, co-dominant stems @1m, signs of decay between the stems @1m, southerly stem is cracked where a limb with included bark has broken out @ 2.5m, heavy ivy growth on main stem into upper canopy, deadwood in mid and upper crown, dieback in upper crown on East side due to compaction on laneway, West side of crown healthy, branches cut back on East side @6m & 8m have no new growth	Fell Tree. With the Southern stem removed due to the decay the tree will be unbalanced with a poor crown on one side. However, retaining the tree should be given consideration by reducing the height to 4m and retain within the hedgerow if enough epicormic growth emerges to sustain it. In accordance with BS 5837 : 2012 4.5.7	U	<10

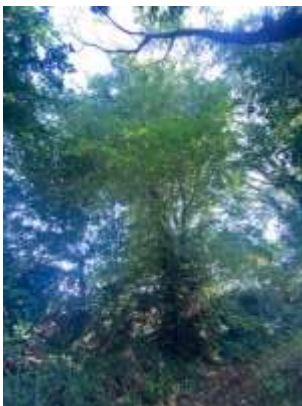
Fig 7 : T777

Tag No.	Species	Age	Height	Diameter	Condition	Crown Spread	RPA (M ²)	Comments	Recommendations	RC	ERC
777	Small leaved lime (<i>Tilia cordata</i>)	M	12m	75cm (x 2)	Fair	N 5m S 3m E 3m W 3m	255	Medium sized tree, co-dominant stems from .5m, large amount of sucker growth at the base West side, minor ivy growth on Northerly stem, canopy is heavier growing North, dense crown with minor crossing branches in mid and upper crown, branches have been cut back previous @2m & 4m West side	Unbalanced tree and will need to be reduced biennially due to its size, the resulting epicormic growth will become a safety issue eventually, it is recommended to fell and remove this tree	U	<10

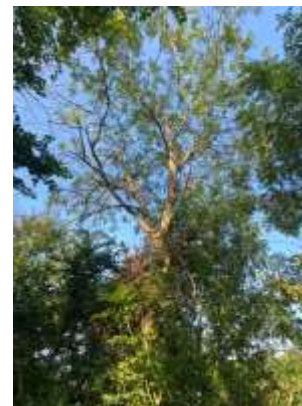
Fig 8 : T778

Tag No.	Species	Age	Height	Diameter	Condition	Crown Spread	RPA (M ²)	Comments	Recommendations	RC	ERC
778	Ash (<i>Fraxinus excelsior</i>)	M	11m	40cm	Poor	N 4m S 4m E 5m W 3m	72	Large trunk, was cut back on West side in the past, poor occlusion on old cuts, tree is leaning East 80° unbalanced crown, dieback on West side, evidence of ash dieback disease (<i>Hymenoscyphus fraxineus</i>)	The tree will not be able to contribute to the landscape going forward and will present a hazard in a year or two because of the ash dieback that it suffers from at present	U	<1

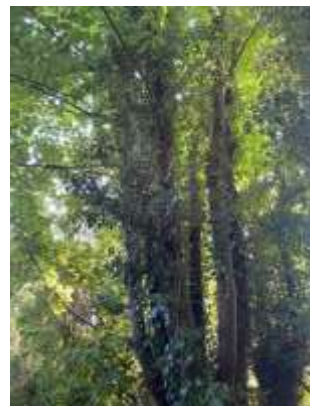
Fig 9 : T779

Tag No.	Species	Age	Height	Diameter	Condition	Crown Spread	RPA (M ²)	Comments	Recommendations	RC	ERC
779	Sycamore (<i>Acer Pseudoplatanus</i>)	M	13m	120cm (x 7)	Fair	N 4m S 3m E 4m W 5m	652	Multi-stemmed (7) @1m, coppiced aprox 20 years previous, compressed wood between the unions of two stems, cambium damage on East @2m from machinery, growing on an earth and stone bank, the tree shows poor form with the multi stem structure, future pollarding will always be a safety issue	It is recommended to fell and remove this tree	U	<10

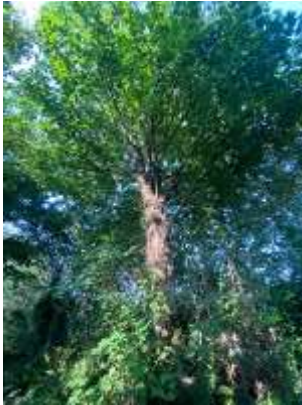
Fig 10 :T780

Tag No.	Species	Age	Height	Diameter	Condition	Crown Spread	RPA (M ²)	Comments	Recommendations	RC	ERC
780	Sycamore (<i>Acer pseudoplatanus</i>)	M	14m	45cm	Fair	N 5m S 4m E 4m W 4m	92	Straight stem to 4m, evenly distributed branch structure, slight lean to the North in upper crown, Heavy ivy was cut previous, branches were cut back on West, sucker growth at the base, epicormic growth on East side where branches were cut @3m, this tree will become a large tree and branch drop under high winds may pose a future hazard to pedestrians and vehicular traffic	It is recommended to fell and remove this tree	U	<10

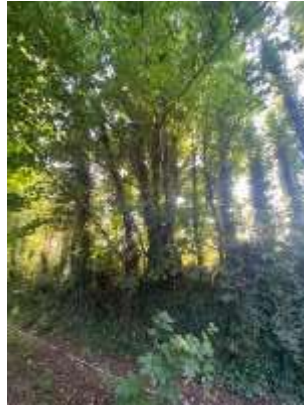
Fig 11 : T781

Tag No.	Species	Age	Height	Diameter	Condition	Crown Spread	RPA (M ²)	Comments	Recommendations	RC	ERC
781	Sycamore (<i>Acer pseudoplatanus</i>)	M	10m	80cm (x 4)	Fair	N 3m S 3m E 5m W 4m	222	Coppiced 20yrs previous @.5m, 4 main stems making up the canopy (2 @.5 & 2 @ 1.5), Heavy ivy growth on all stems, tree is congested with the elms on North and South, not a tree of significance but contributing to the landscape, not an immediate hazard, dense crown with crossing branches in mid and upper crown	Remove ivy and re-assess for any defects, clean crown of any crossing, dead or cracked branches, Consider felling and replanting with a more suitable tree species with higher amenity value	C3	>20

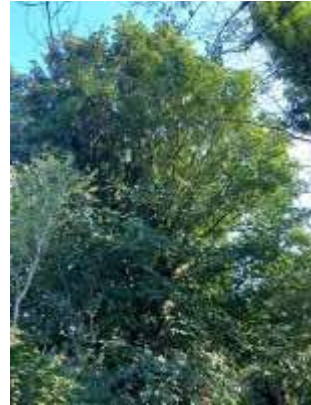
Fig 12 : T782

Tag No.	Species	Age	Height	Diameter	Condition	Crown Spread	RPA (M ²)	Comments	Recommendations	RC	ERC
782	Sycamore (<i>Acer pseudoplatanus</i>)	M	13m	35cm (x 3)	Poor	N 4m S 5m E 4m W 5m	N/A	Major basal decay between all three stems, dangerous tree, relative to targets that may present themselves	Fell tree	U	N/A

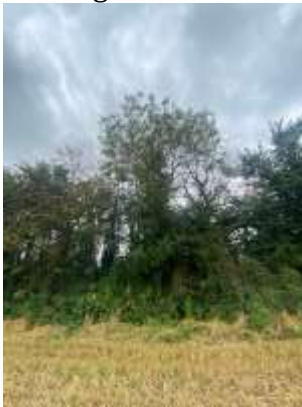
Fig 13 : T783

Tag No.	Species	Age	Height	Diameter	Condition	Crown Spread	RPA (M ²)	Comments	Recommendations	RC	ERC
783	Ash (<i>Fraxinus excelsior</i>)	Y	13m	20cm	Poor	N 4m S 3m E 3m W 4m	N/A	Stem is cracked @1m, Hazardous tree	Fell tree	U	N/A

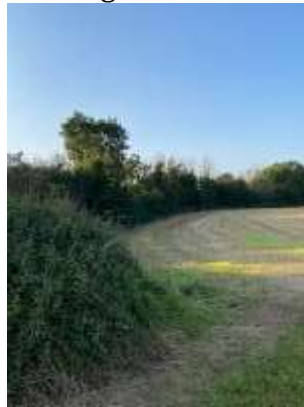
Fig 14: Hedge1

Hedge No.	Species	Height	Width	Age	Condition	Comments	Recommendations	Category Grading
1	Bracken (<i>Pteridium aquilinum</i>) Rye grass (<i>Lolium perenne</i>) Ivy (<i>Hedera hibernica</i>) Willowherb (<i>Epilobium</i>) Stinging nettle (<i>Urtica dioica</i>) Bramble (<i>Rubus sp</i>) Blackthorn (<i>Prunus spinosa</i>)	5m	4m	Y	Fair	Constructed of an earth and stone ditch, is 138 m in length, the hedge is wide at the South side @6m but tapers to 3m after 30m, not maintained regularly, some trees have been pollarded approx five years previous, there is one large ash, blackthorn and elm understorey trees coming through, dense bramble and bracken for the first 30m with low density willowherb also, after 30m there is a line of elms 5m in height, mostly dead, some healthy elm saplings coming through, after 30m the field layer is made up of ivy, rye grass, low density bracken and stinging nettle, T773	This hedgerow is of minor significance and its removal is recommended	Historical -1 Species diversity - 1 Ground flora - 2 Structure - 2 Habitat Connectivity - 0 Landscape - 2

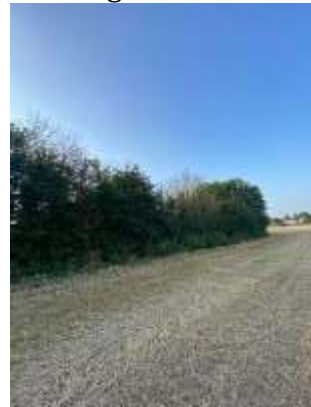
Fig 15 : Hedge 2

Hedge No.	Species	Height	Width	Age	Condition	Comments	Recommendations	Category Grading
2	Bracken (<i>Pteridium aquilinum</i>) Rye grass (<i>Lolium perenne</i>) Bramble (<i>Rubus sp</i>) Blackthorn (<i>Prunus spinosa</i>) Hawthorn (<i>Crataegus monogyna</i>) Elm (<i>Ulmus glabra</i>) Bindweed (<i>Convolvulus</i>)	5m	3m	M	Fair	This hedge comprises an earth and stone ditch & is 70 m in length, East side of laneway. It is made up with mainly small elm trees of diameter averaging 10cm, some of these trees are dead but most are still alive presenting a healthy hedge although in need of maintenance. There is a healthy understory of blackthorn beneath the canopy of the elms, beneath the blackthorn is a field layer of dense bracken, bindweed was observed in places, this will become dense and will eventually engulf some species if left unchecked. The lower canopy branches of the elms and blackthorn are encroaching into the field on the East	This hedgerow is of low value and its removal is recommended	Historical -1 Species diversity - 2 Ground flora - 1 Structure - 2 Habitat Connectivity -0 Landscape - 2

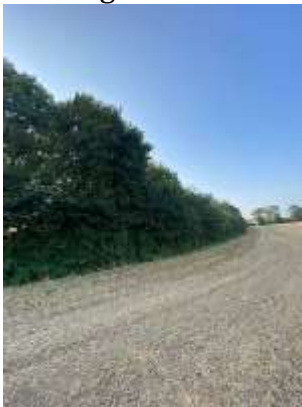
Fig 16 : Hedge 3

Hedge No.	Species	Height	Width	Age	Condition	Comments	Recommendations	Category Grading
3	Elm (<i>Ulmus glabra</i>) Lime (<i>Tilia cordata</i>) Blackthorn (<i>Prunus spinosa</i>) Honeysuckle (<i>Lonicera periclymenum</i>) Bindweed (<i>Convolvulus</i>) Ivy (<i>Hedera hibernica</i>) Stinging nettle (<i>Urtica dioica</i>)	6m	4m	M	Fair	This hedge is made of an earth and stone ditch & is 178 m in length, East side of laneway. There is a small leaved lime located 3m from the start of hedge 3, the hedge contains mainly healthy elm species small trees averaging 10cm in stem diameter and 4m in height, there are some towards the end of hedge 3 that are dead, under these are blackthorn species coming through, the field layer is dense with bracken, ivy and medium density nettle, bindweed was observed, T777	This hedgerow is of low value to the site and its removal is recommended	Historical -1 Species diversity - 2 Ground flora - 2 Structure - 2 Habitat Connectivity -0 Landscape - 2

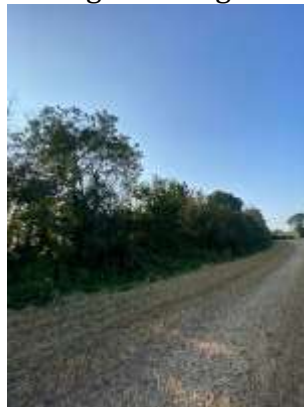
Fig 17 : Hedge 4

Hedge No.	Species	Height	Width	Age	Condition	Comments	Recommendations	Category Grading
4	Sycamore (<i>Acer pseudo platanus</i>) Elm (<i>Ulmus glabra</i>) Blackthorn (<i>Prunus spinosa</i>) Elder (<i>Sambucus nigra</i>) Bramble (<i>Rubus</i>) Honeysuckle (<i>Lonicera periclymenum</i>) Bindweed (<i>Convolvulus</i>) Ivy (<i>Hedera hibernica</i>) Stinging nettle (<i>Urtica dioica</i>)	6m	4m	M	Fair	This hedge is on an earth and stone ditch is 136 m in length East side of laneway. Poorly maintained, it has a notable amount of sycamore relative to hedges 1, 2 & 3. There are small dead elms in the centre and towards the end with sycamore saplings coming through as an understorey, sporadic appearances of blackthorn and elder. There is dense ivy on the ground and on elm stems, also dense bramble and nettle for the last 20m at the North end of the hedgerow. The end of the hedge is 6m wide for the last 10m, T778 ash, T780 sycamore, large dead elm, T782 sycamore	Remove any bindweed that may be present, remove any dead trees, remove ivy from tree stems, sideface and reduce height to 4m where possible	Historical -1 Species diversity - 2 Ground flora - 2 Structure - 2 Habitat Connectivity -0 Landscape - 2

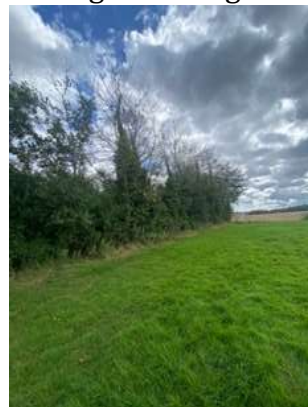
Fig 18 : Hedge 5

Hedge No.	Species	Height	Width	Age	Condition	Comments	Recommendations	Category Grading
5	Sycamore (<i>Acer pseudo platanus</i>) Elm (<i>Ulmus glabra</i>) Honeysuckle (<i>Lonicera periclymenum</i>) Bindweed (<i>Convolvulus</i>) Ivy (<i>Hedera hibernica</i>) Stinging nettle (<i>Urtica dioica</i>) Gorse (<i>Ulex sp</i>)	2m	3m	M	Fair	This hedge on an earth and stone ditch is 189 m in length on the West side of the laneway, there is a group of dead elms at the start and for 30m the hedge is made up of gorse, bramble and nettle 2m in height, after 30m the hedge changes after a drainage dyke that runs into it West to East. From this point on there is a line of elms approximately 5m in height, dense ivy is growing on most of the stems, T771 sycamore, T772 ash, dead elm, T774 ash	This hedgerow is of minor significance and its removal is recommended	Historical -1 Species diversity - 2 Ground flora - 2 Structure - 2 Habitat Connectivity -0 Landscape - 2
