Proposed Residential Development,
Water Rock, Midleton

Road Safety Audit Stage 1

MAY 2022

Client	Haven Falls Ltd.
Project Title	Residential Development
Project Location	Water Rock, Midleton, Co. Cork
Document Title	Road Safety Audit Stage 1
Document No.	MHL-21154TT-WATER ROCK MIDLETON-DOC03-RSA
Job No.	21154TT

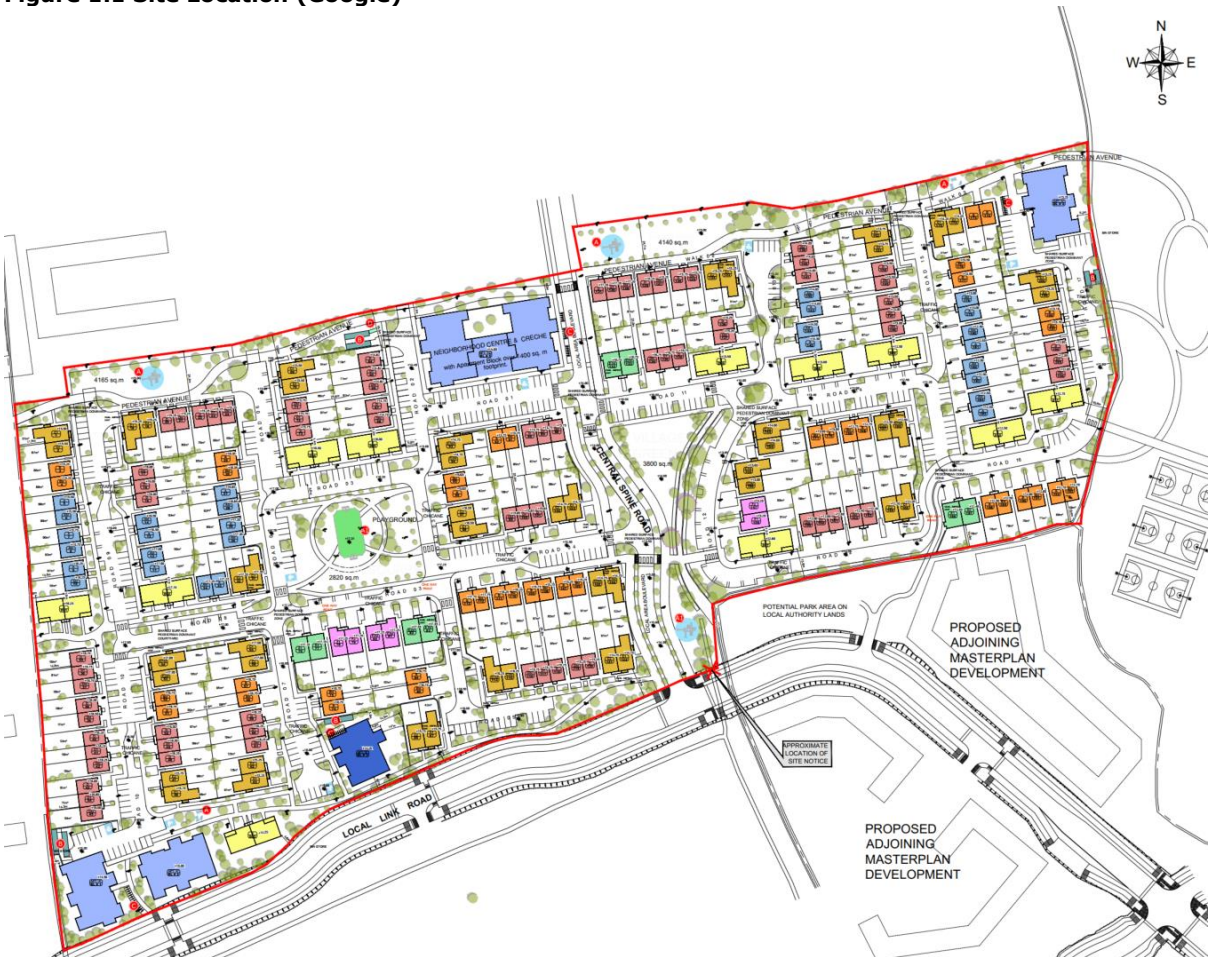
Figure 1.2 Proposed Development site (GMA)

Vehicular and pedestrian/cycle access is to be accommodated at the proposed entrance. The site location and proposed site layout is shown in following Figures 1.1 and 1.2. See the Site Layout Plan drawing accompanying the application, produced by Gittens Murray Architects Ltd.

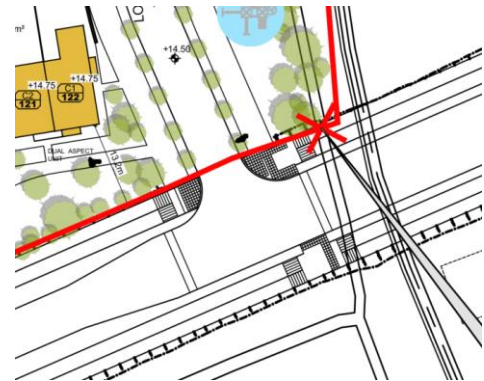
No visibility splays layouts were provided for this audit. Also forward visibility to the proposed traffic signal heads at the proposed entrance junction should be provided, clear of high-level trees. Failure to provide appropriate visibility at the entrance junctions/internal junctions/onto and from pedestrian crossings may lead to collisions between vehicles travelling in opposing directions or between vehicles and pedestrians.

Ensure appropriate junction visibility splays and forward visibility are provided at all junctions within of the proposed site development. Also ensure that appropriate visibility is provide to all junctions and from all pedestrian crossings. Particular care should be taken in the placement of landscaping in this regard.

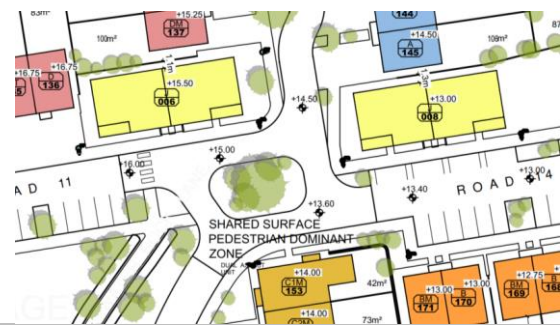
The proposed layouts appear to indicate a one-way street circulatory configuration at shared surface locations. No appropriate lining or signing is shown in the design layouts. Unclear designation of one-way streets internal roadways may cause conflicting traffic movements, potentially leading to collisions between passing vehicles.

Provide one way traffic signing and road markings in accordance with relevant design standards to designate traffic flow direction and priority and one way flow designation.
