Tree Survey & Arboricultural Impact Assessment of mature trees and hedgerows at a site in Waterrock, Co. Cork

Date : 17/10/22

Haven Falls Ltd,
C/o McCutheon Halley,
Joyce House,
6 Barrack Square,
Ballincollig,
Co.Cork

George Earle, *Dip Arb, TechArbA, Cert Hort*

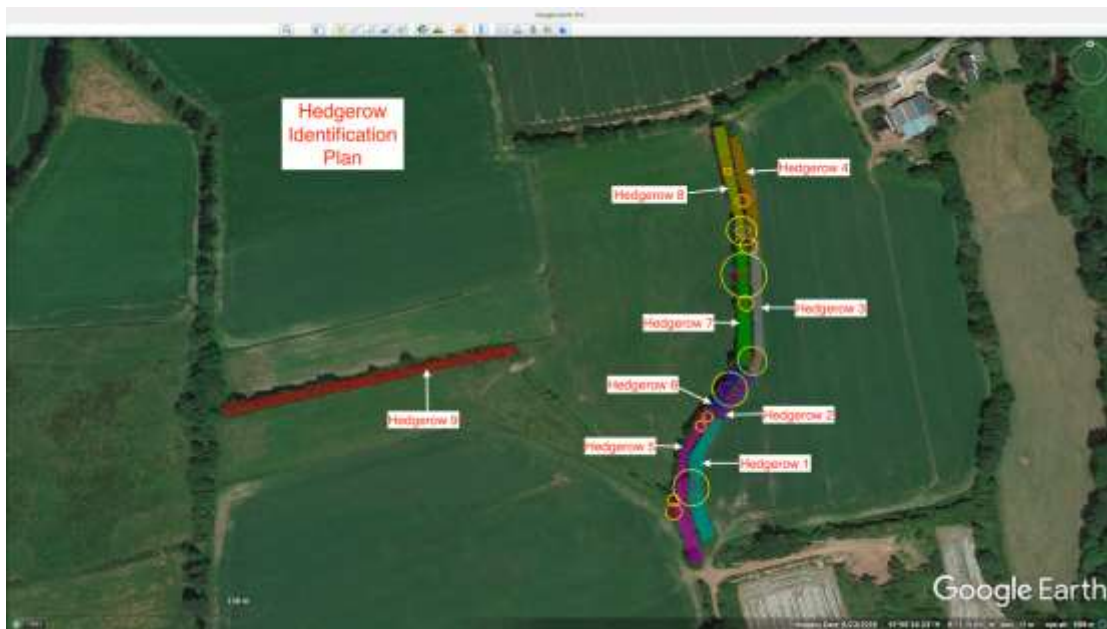
Fig 23 : Aerial photo of hedgerows in total that were surveyed.

The hedgerows were not connected at either end to any other hedgerow and therefore scored low in Habitat Connectivity (0). On the South end of hedge 1 & 5 and the North end of hedge 4 & 8 there are dense sections of bramble (*Rubus sp*) and bracken (*Pteridium aquilinum*) which are not of arboricultural importance. Towards the centre sections of hedges 2, 3, 6 & 7 blackthorn (*Prunus spinosa*) is beginning to come through as a strong understorey tree. Hawthorn is also beginning to emerge. Presently however the understorey is only sparsely populated with these species and a healthy consistent hedgerow of strong understorey small trees is absent. There are sections along which the field layer of bramble, bracken and nettle (*Urtica dioica*) are overgrown and only resembling a hedge by the dense foliage they provide at ground level. The hedges recommended for removal are hedge no 1, 2, 3, 5, 6, 7, 9. These can be seen in Fig 23.
